6 National Dam Inspection Program. Frances Slocum Dam (NDS-ID-PA-00574; DER-ID-40-218), Susquehanna River Basin, Abrahams Creek, Luzerne County, Pennsylvania. Phase I Inspection Report.

FRANCES SLOCUM DAM

NDS ID No. PA-00574
DER ID No. 40-218

PHASE I INSPECTION REPORT
NATIONAL DAM INSPECTION PROGRAM

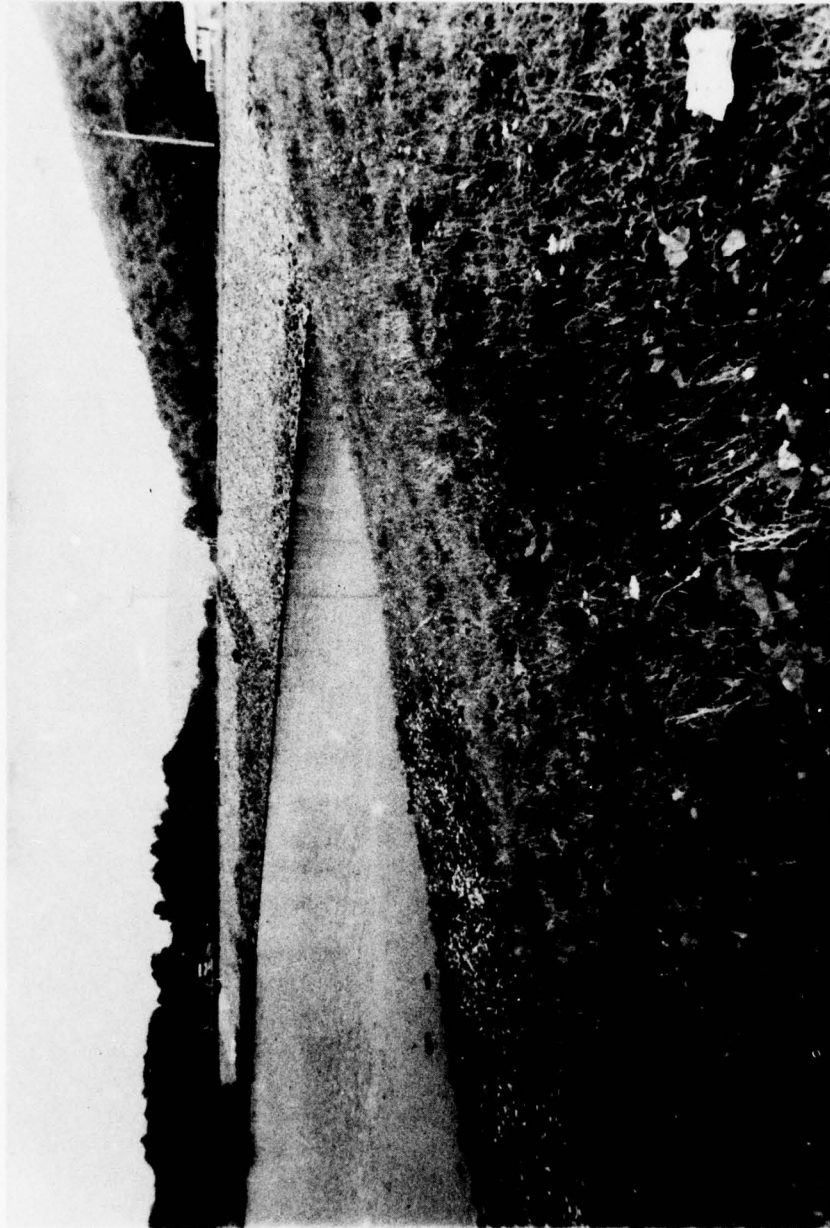
Embankment.
View from Upstream.

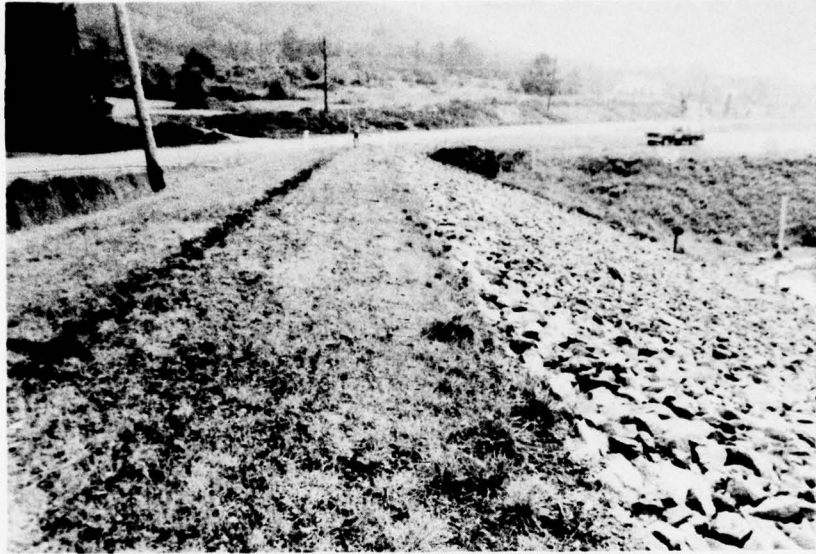
(2) The embankment slopes were in excellent condition (Photographs A, B, C, and D). Riprap on the upstream slope was intact to the top of the dam, and there were no weeds or brush growing in the riprap. The downstream slope is covered with a mixed growth of grass, crown-vetch, and weeds about 2 feet high. There was no brush growing on the downstream slope.

A. Junction of Embankment and Right Abutment.
Staff Gages at Right.

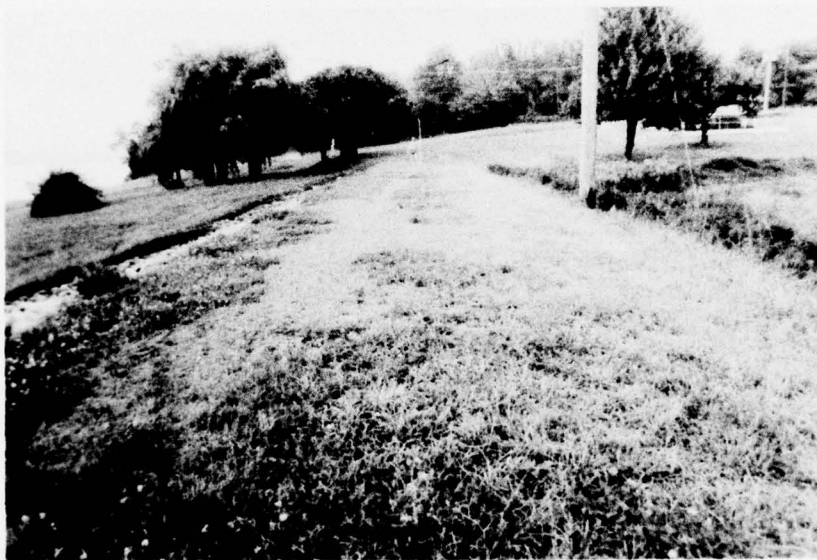
B. Junction of Embankment and Left Abutment.

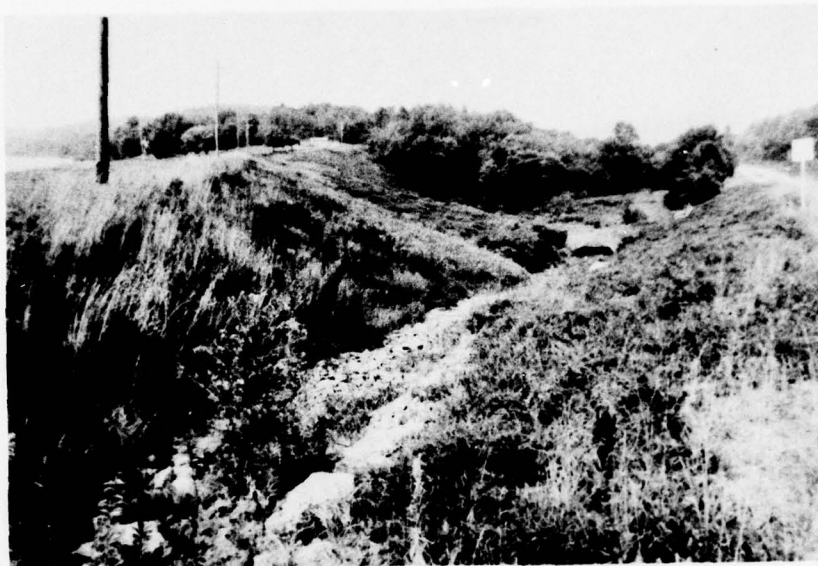
(3) The embankment toe gutters were generally in good condition. The gutter along the right abutment is rock-lined, and there were no signs of erosion (Photograph C). A concrete gutter along the downstream toe had a slight amount of vegetation growing in the joints.

C. Downstream Slope of Embankment.
View from Right Abutment.

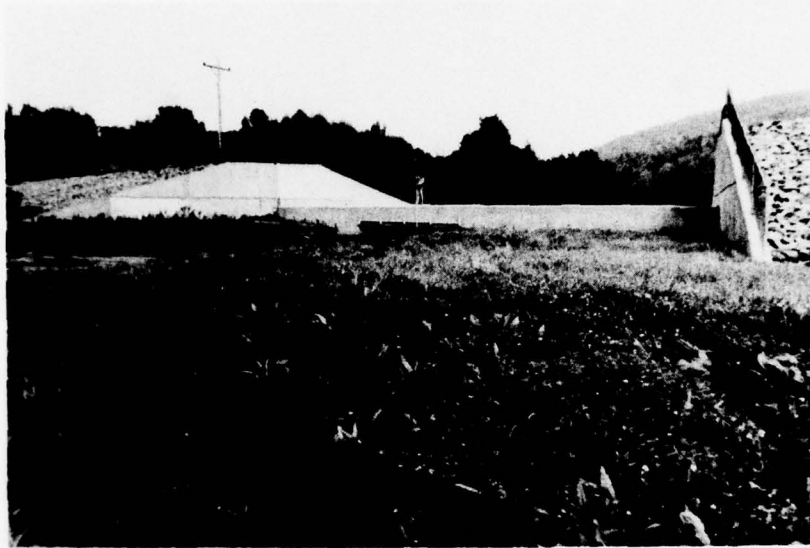
(1) Spillway. The approach area to the spillway was clear (Photograph E). The bar screen over the opening in the spillway weir was well-maintained and free of debris (Photograph F). Some cracks in the concrete were visible on the downstream side of the spillway weir where the opening in the spillway weir transitions to a channel along the centerline of the spillway chute (Photographs G and L). Attempted surface repairs by the Park personnel using an epoxy cement have not been successful. Except for the aforementioned cracks in the vicinity of the opening in the spillway weir, the ogee weir was in good condition (Photographs G and J).

E. Spillway Approach Channel.

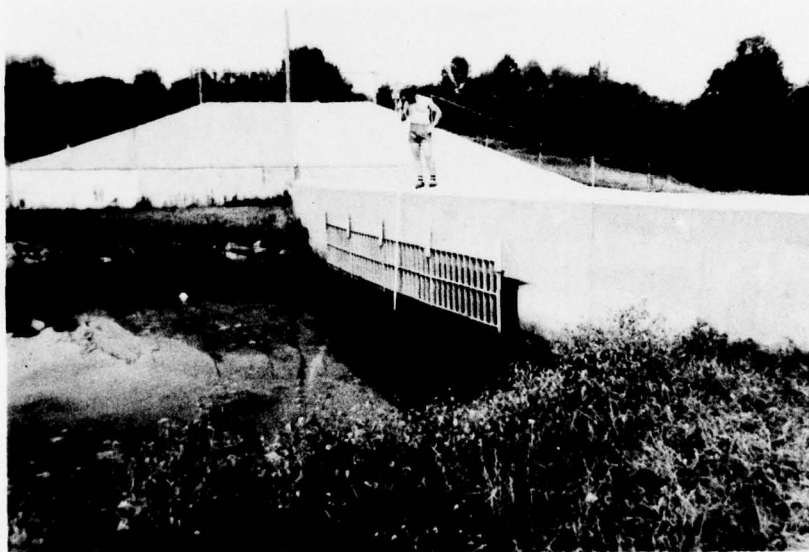
F. Bar Screen Over Low-Flow Opening in Spillway.

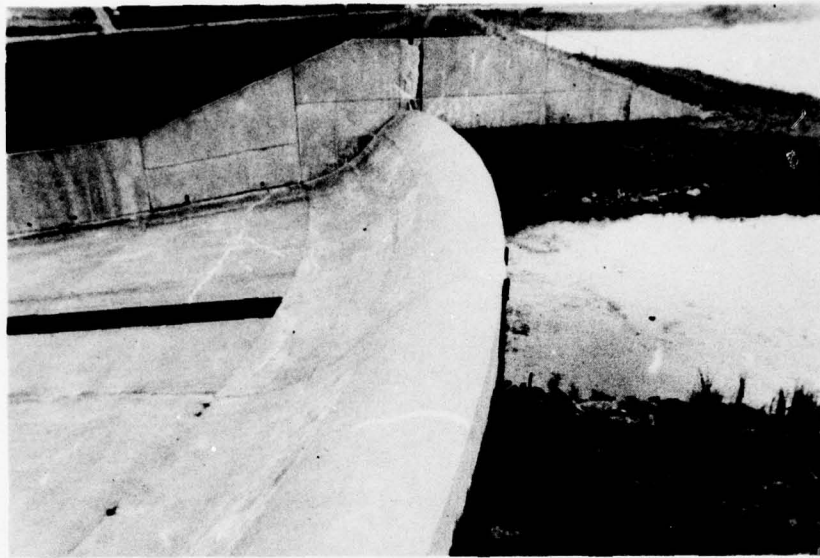
(4) Spillway Chute Slab and Flip Bucket. The spillway chute slab had no major deficiencies. Several fine transverse cracks were apparent, but most of them did not go all the way across the slab monoliths. One slab monolith has settled slightly, but there were no apparent adverse effects. The chute slab and flip bucket are shown on Photographs G, M, and N.

G. Concrete Ogee and Right Training Wall.

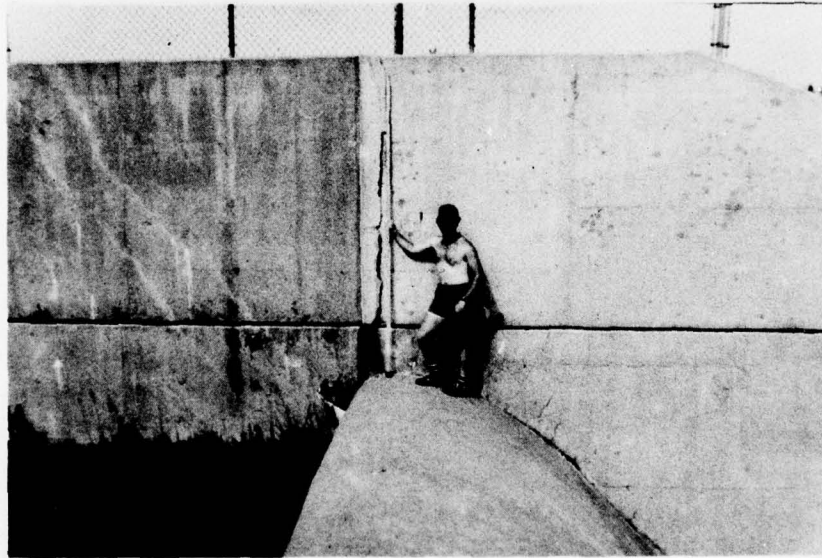
(3) Spillway Left Training Wall. The condition of the left training wall of the spillway is similar in character to the right training wall but not nearly as severe (Photograph H). The first and second monoliths are in good condition. The third monolith has 2 fine diagonal cracks, and the fourth monolith is in good condition. The joint between the third and fourth monoliths is badly cracked and ready to spall (Photograph H). Differential movement at the tops of the monoliths at the joint was 0.25 inch. The rest of the monoliths along the chute and flip bucket are in good condition except for one surface spall on one of the monoliths.

(2) Spillway Training Walls. The condition of the right training wall of the spillway is unsatisfactory. The ends of the waterstop are exposed, and the effectiveness of the waterstop is doubtful. During periods of high pool levels, seepage could develop through the joint that might cause piping of embankment materials. Loss of embankment materials could cause a condition that might result in overtopping of the embankment. While the condition of the left training wall is not as severe as the right wall, it is considered to be part of the same problem. The similarities between the deficiencies of the right and left walls suggest that the problems arose as a result of the design of the walls. Review of previous inspection reports clearly indicates that the deficiencies had become apparent by 1973, and possibly began as early as 1969, at which time the project was 4 years old. The inspection reports also indicate substantial worsening of the condition between 1973 and 1975. Without additional study, it is not possible to determine whether the problem is still active or whether it has stabilized. It should be recognized that a great flood would impose loads on the walls that would exceed those have been experienced to date.

H. Concrete Ogee and Left Training Wall
Showing Cracking at Joint and on Upstream Monolith.

(2) Perform investigations required to determine the cause of unsatisfactory performance of the spillway training walls and make repairs.

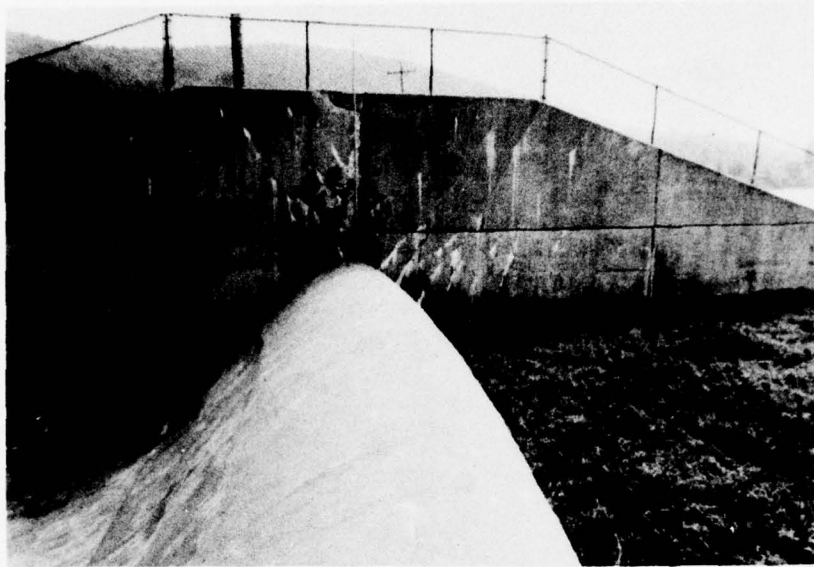
(2) Spillway Right Training Wall. The right training wall of the spillway has several deficiencies. The most upstream monolith, or first monolith, has one vertical crack at its upstream end that extends through the wall. The third monolith, which is the monolith just upstream of the concrete ogee weir, has 7 fine diagonal cracks on its face (Photograph J). Similarly, the fourth monolith has 3 fine diagonal cracks and one fine vertical crack. The joint between the third and fourth monoliths is spalled to a depth of 4 inches and the waterstop is exposed (Photographs J and K). About one inch of differential movement was measured between the tops of the third and fourth monoliths. The inside face of the third monolith has an inward inclination of about 77V on 1H, while the inside face on the fourth monolith has an inward inclination of about 96V on 1H. Downstream from the fourth monolith, the monoliths along the chute and flip bucket are in good condition.

J. Concrete Ogee and Right Training Wall Showing Monolith Cracking and Spalling at Joint.

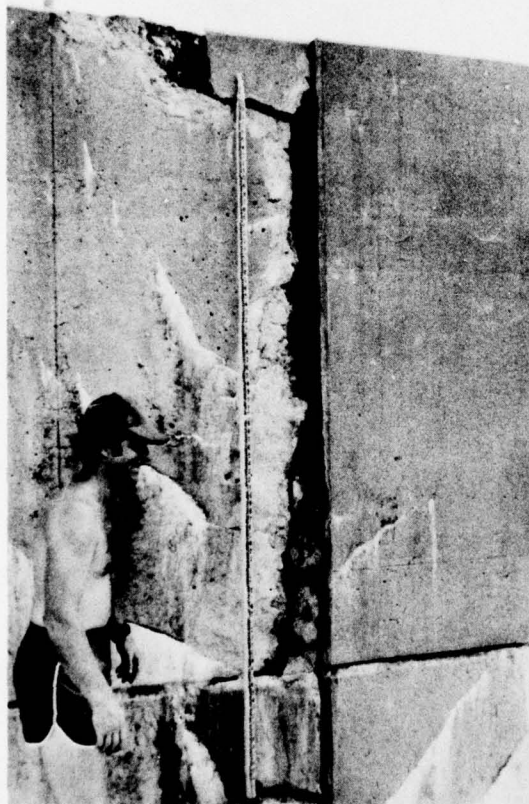
K. Detailed View of Cracking and Spalling at Joint.

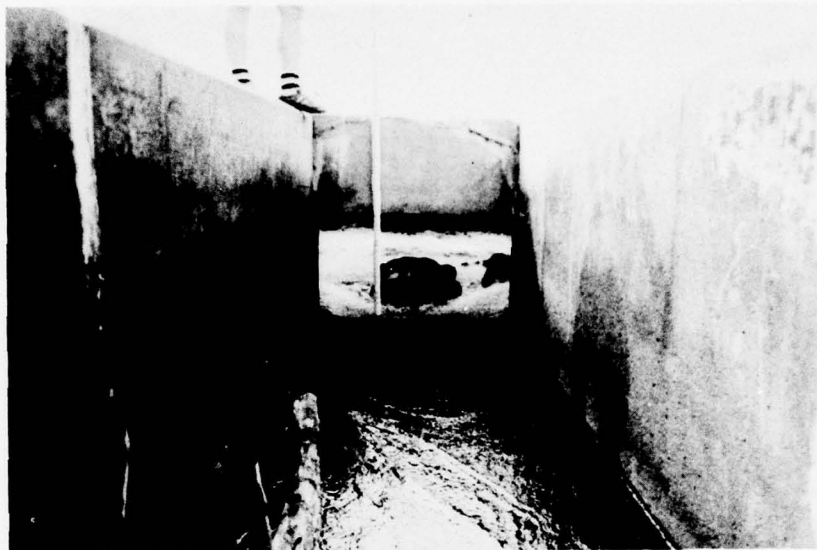
L. Low-Flow Outlet at Downstream Side of
Spillway Weir.

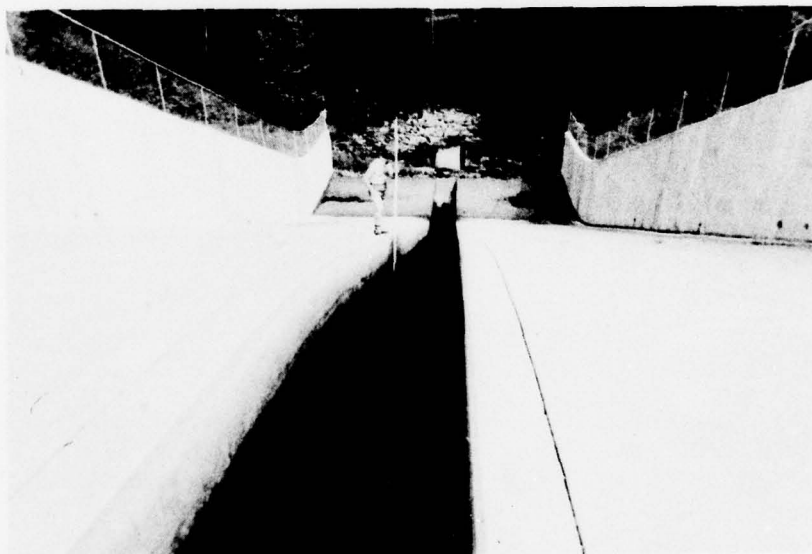
(3) Spillway Chute Slab. The fine transverse cracks on the spillway chute slab and the minor settlement of one slab do not present hazard to the dam. However, the concrete might deteriorate in the future to the extent that repairs would be warranted.

M. Concrete Chute and Flip Bucket.

(4) Monitor condition of spillway slab concrete where cracks exist. If conditions worsen, repairs should be undertaken.

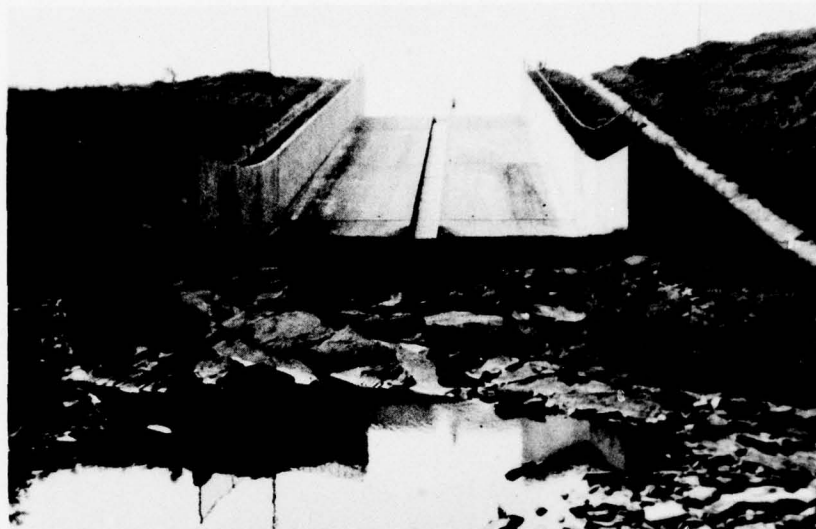
N. Concrete Chute, Flip Bucket,
and Paved Gutters.

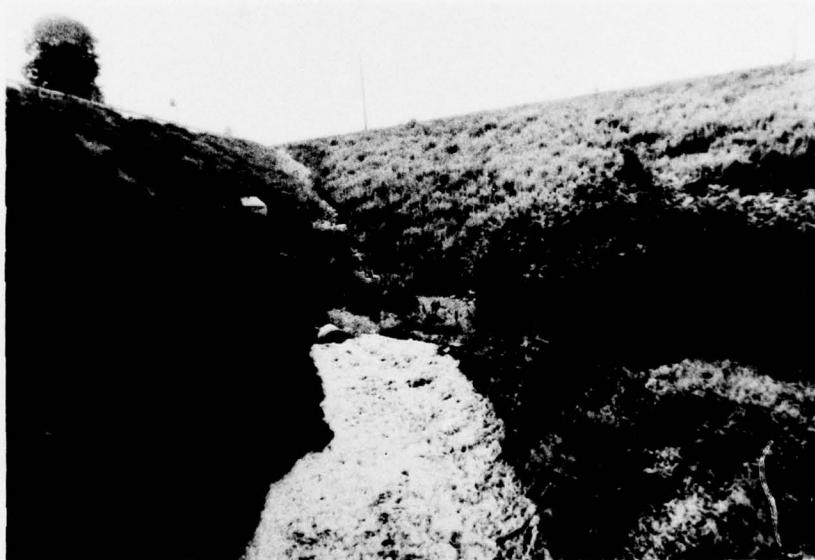
O. Flow from Outlet Works during Valve Operation.
